# Manhole Inspection Summary

Manhole # S15KK\_009MH

Insp Date: **2/24/09 1:59 PM**

**Location** Address: **2707 ASBURTON ST**

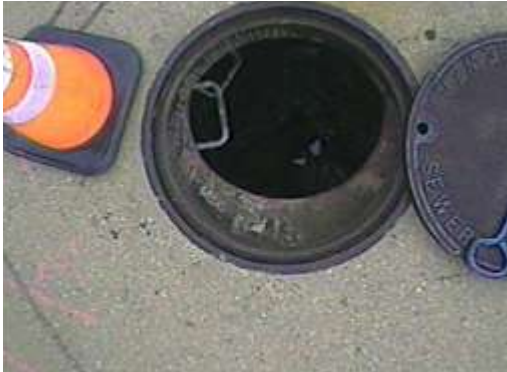
Defect 2

Offset: **5** (in.)

frame offset

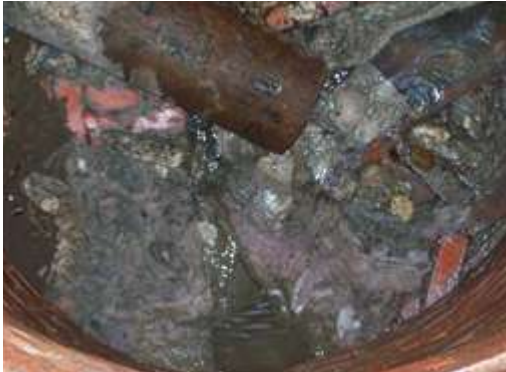
Defect 1

☒ **Evidence Of Surcharge** Depth: **4** (ft.) ☐ Active Surcharge Present

ASUR

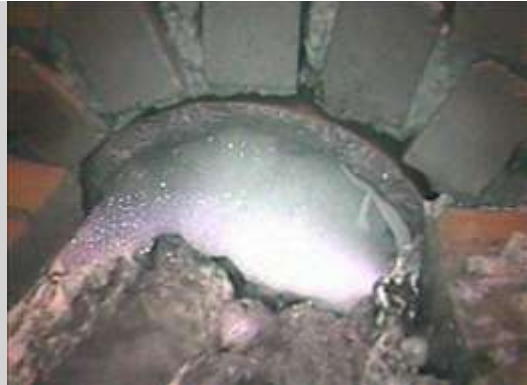
12 O'Clock Outflow

8 in. Circular Gravity Sewer  
Pipe Out @ 12 O'Clock

Pipe Height: (in.) Direct  
Pipe Material: **Clay** ☐ Pipe Lined  
Invert Depth: **8.79** (ft.) Flow Characteristics: **Slow**  
Deposits: ☐ None ☒ Mud ☒ Sludge ☒ Debris ☐ Grease  
Silt Depth: **5** (in.) Deposits Extent: **Heavy**  
Infiltration: **None** Pipe Seal Cond: **Cracked**

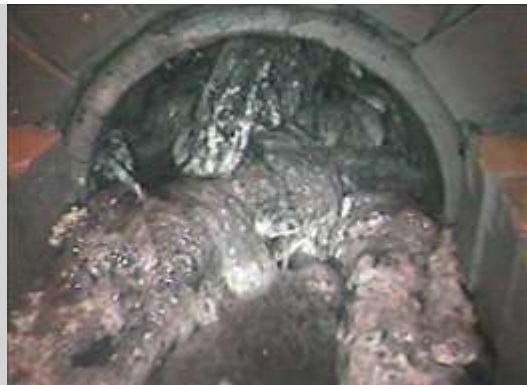
3 O'Clock Inflow

8 in. Circular Gravity Sewer  
Pipe In @ 3 O'Clock

Pipe Height: (in.) Direct  
Pipe Material: **Clay** ☐ Pipe Lined  
Invert Depth: **8.36** (ft.) Flow Characteristics: **Slow**  
Deposits: ☐ None ☒ Mud ☒ Sludge ☒ Debris ☐ Grease  
Silt Depth: **5** (in.) Deposits Extent: **Heavy**  
Infiltration: **None** Pipe Seal Cond: **Cracked**

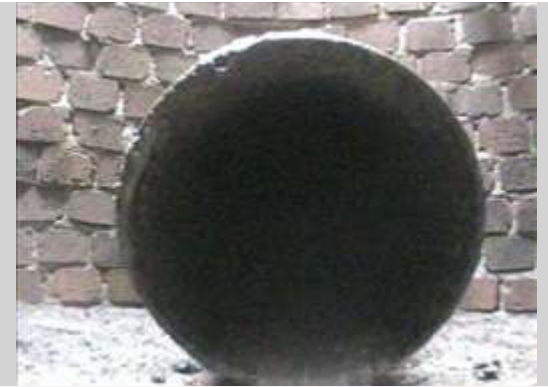
7 O'Clock Inflow

8 in. Circular Gravity Sewer  
Pipe In @ 7 O'Clock

Pipe Seal Cond: **Sound**
